NORTH SHORE STABILITY STUDY
GEO TECHNICAL REVIEW OF THE EXISTING
SHORELINE SLOPE STABILITY

MARCH 1993

CITY OF NANAIMO

HBT AGRA LIMITED
Nanaimo, B.C.

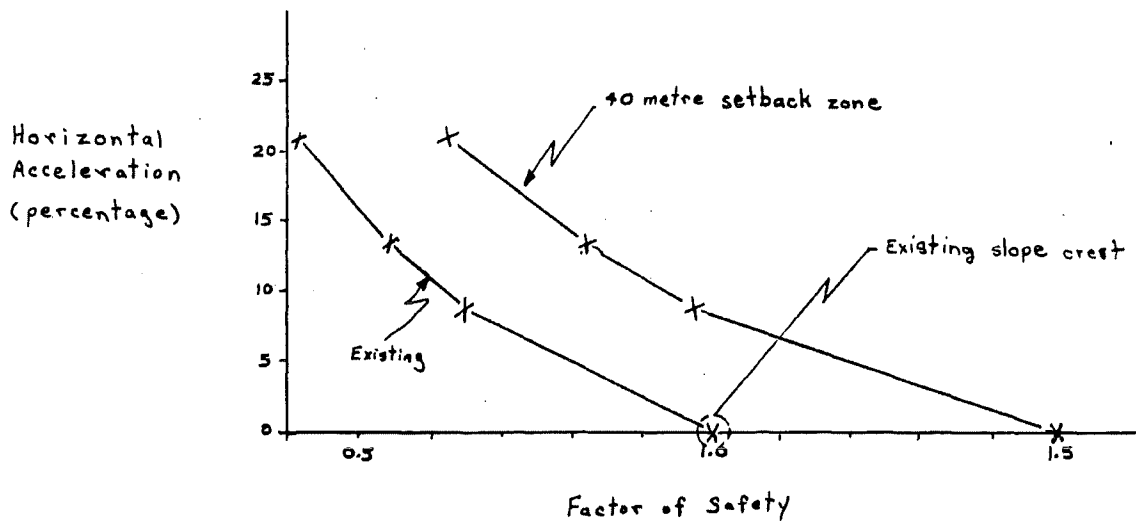
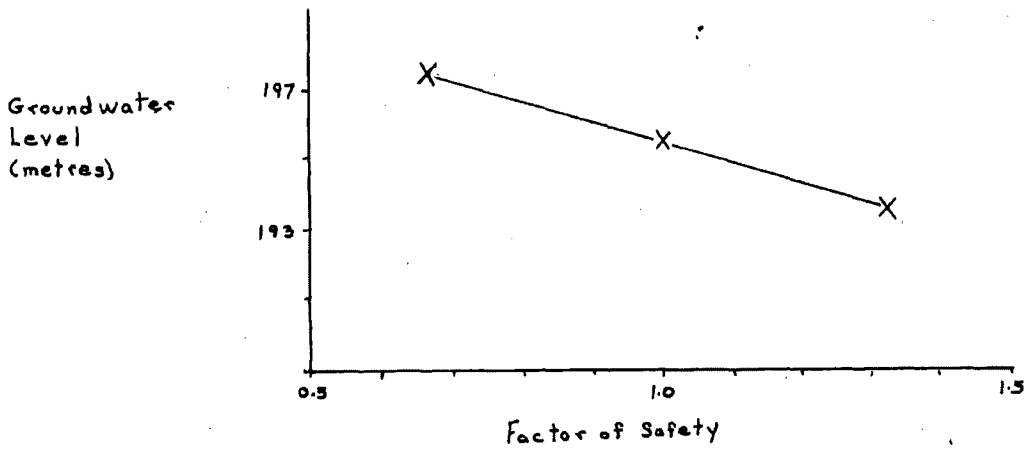
REGIME IV

Analyses carried out for the Sealand Park failure, which has moved in the last year (factor of safety assumed to be 1.0), included evaluating the existing conditions of failure such as material strengths and piezometric (groundwater) pressures. The analysis indicated that the factor of safety generally increases with distance inland of the crest or head scarp. Under the modelled failure conditions, a factor of safety against failure of 1.5 was found at roughly 40 metres south of the head scarp. Parametric analyses indicate that a difference in the interpreted piezometric surface (groundwater level) of 2 metres changes the factor of safety by 20 to 30 percent and that any earthquake loading significantly reduces the factor of safety, as shown on Figure 2.1.

Parametric Analysis
Regime IV - Sealand Park.
North Slope - Nanaimo

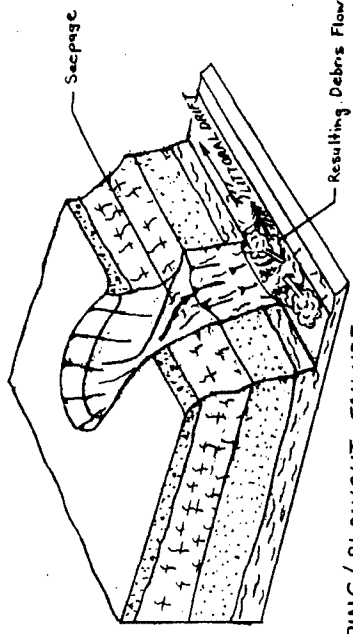
- Regressive Piping or Blowout Failures - roughly the same magnitude as sloughing or slab failures, however, the triggering mechanism is that of pore (groundwater) pressure buildup in sandy lenses or beds due to vegetation cover, surficial soils or dumping of fill. Given the appropriate natural geologic and groundwater conditions, this type of failure appears to occur in cycles as vegetation matures, mixes the soil and restricts groundwater seepage until failure occurs. The dumping of fill and debris accelerates the restriction process and will result in failure of the debris, vegetation and some natural materials.

PIPING/ BLOWOUT-FAILURE

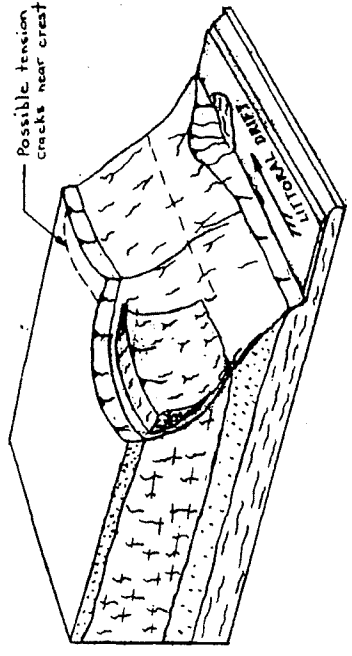
- Minor Sloughing or Slab Failures - generally minor failures involving less than 100 cubic metres of material and regression of a few metres or less per failure episode. Crest, mid-slope and toe failures are included in this category which often result from over-steepened slopes that primarily fail in tension. Contributing factors include stress relief, pore pressure dissipation, softening due to weathering, and saturation from direct precipitation or concentrated runoff.

MINOR SLOUGHING OR SLAB FAILURES

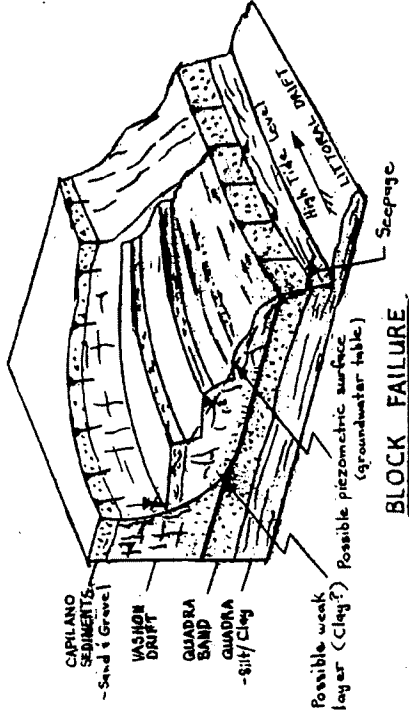
- Block Failures - significantly larger in size and magnitude than the above failure modes. The Sealand Park/ Driftwood Place failure, for example, is estimated to involve more than 300,000 cubic metres of material. These failures are considered to represent classical rotational - translational failures that are more deep seated than those above and can therefore be analyzed as true shear failures.

BLOCK FAILURE

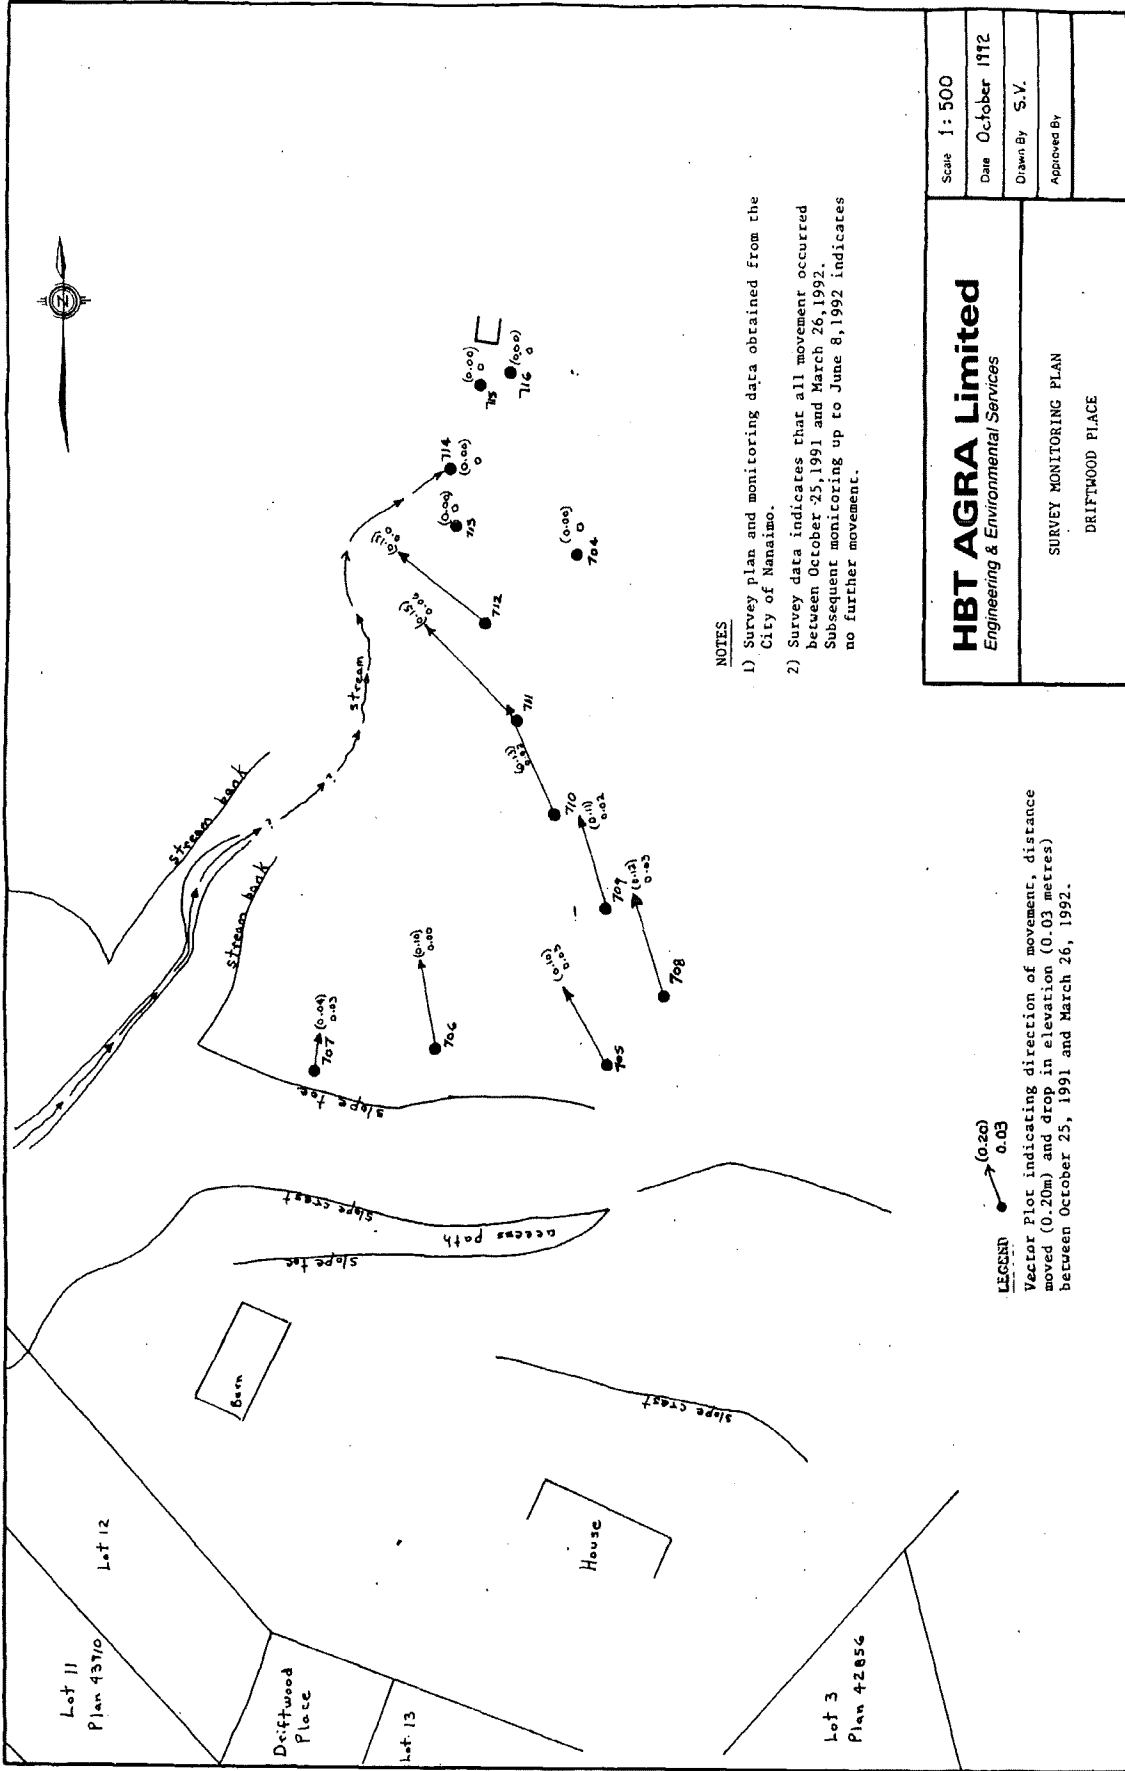
- 1) Survey plan and monitoring data obtained from the City of Nanaimo.
- 2) Survey data indicates that all movement occurred between October 25, 1991 and March 26, 1992. Subsequent monitoring up to June 8, 1992 indicates no further movement.

LEGEND
 Vector Plot indicating direction of movement, distance moved (0.20m) and drop in elevation (0.03 metres) between October 25, 1991 and March 26, 1992.

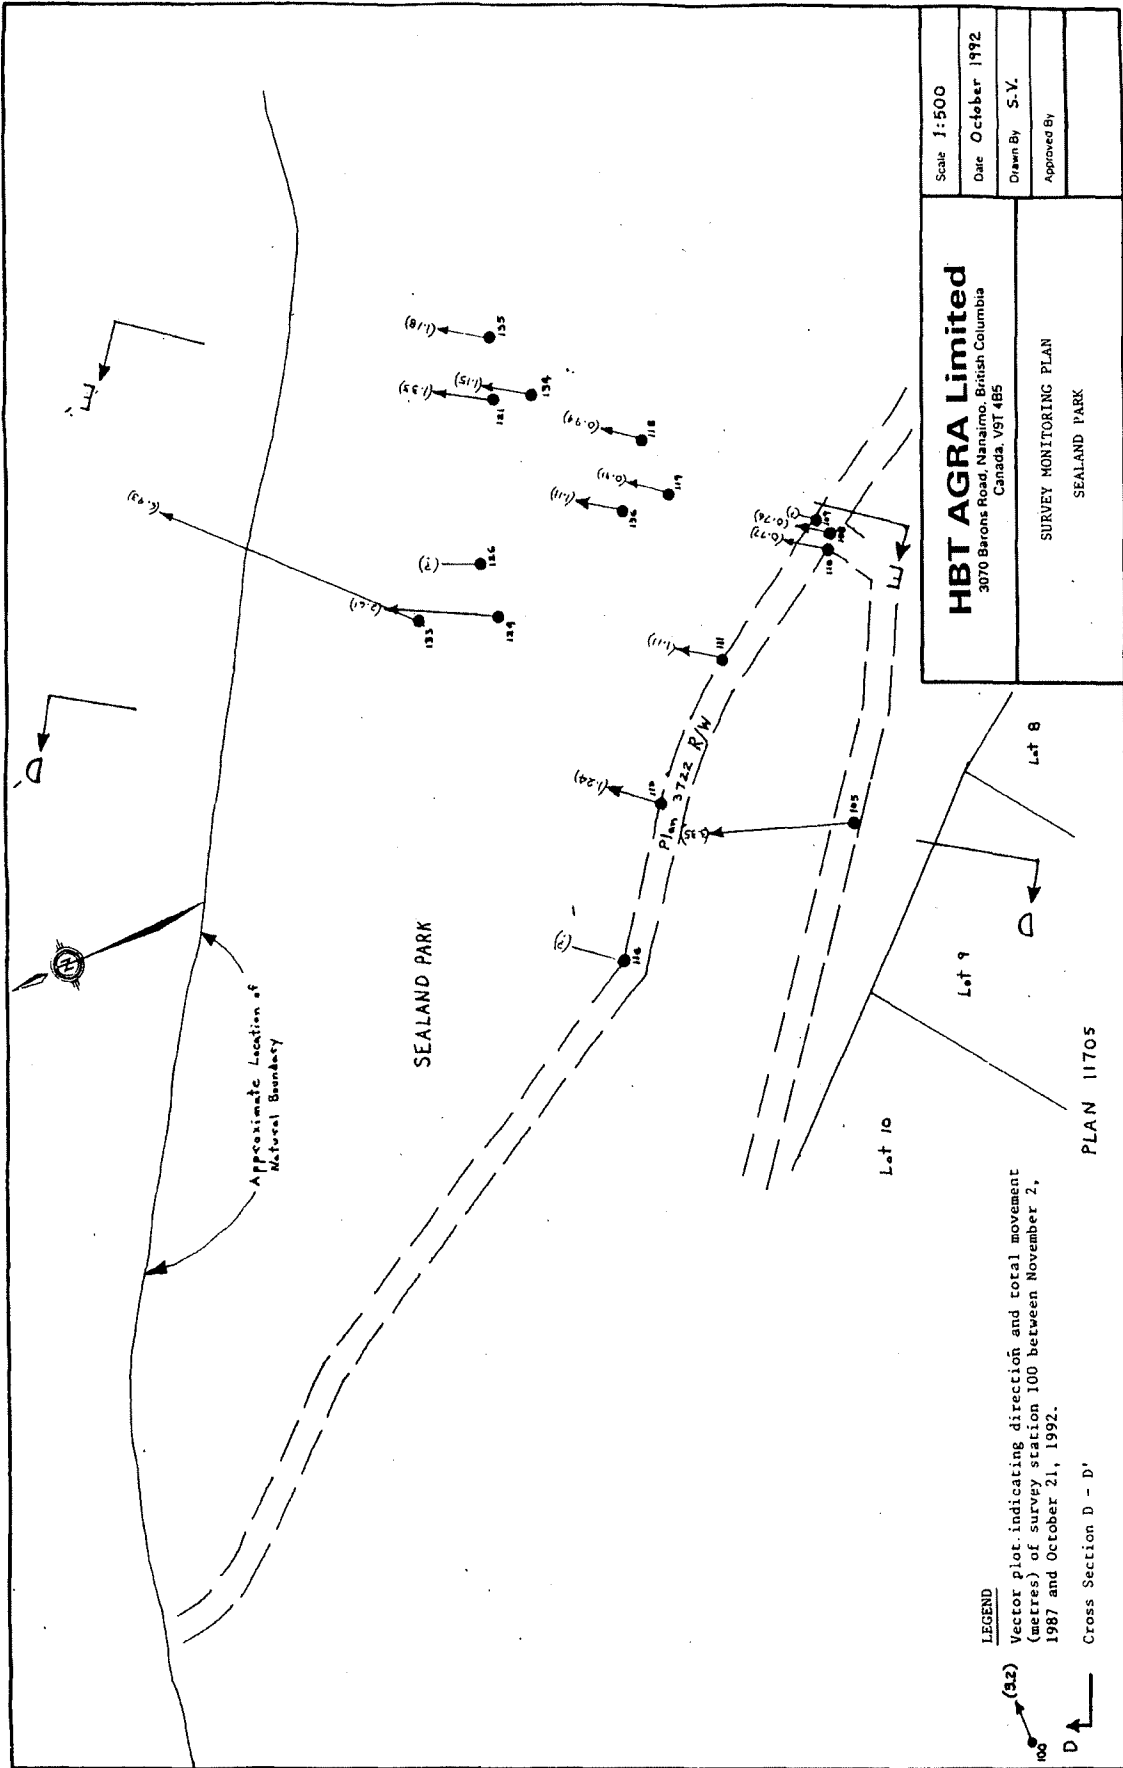
HBT AGRA Limited 3070 Barons Road, Nanaimo, British Columbia Canada, V9T 4B5		Scale 1:500
Date October 1992		Drawn By S.V.
Approved By		Approved By
SURVEY MONITORING PLAN SEALAND PARK

LEGEND
 Vector plot indicating direction and total movement (metres) of survey station 100 between November 2, 1987 and October 21, 1992.

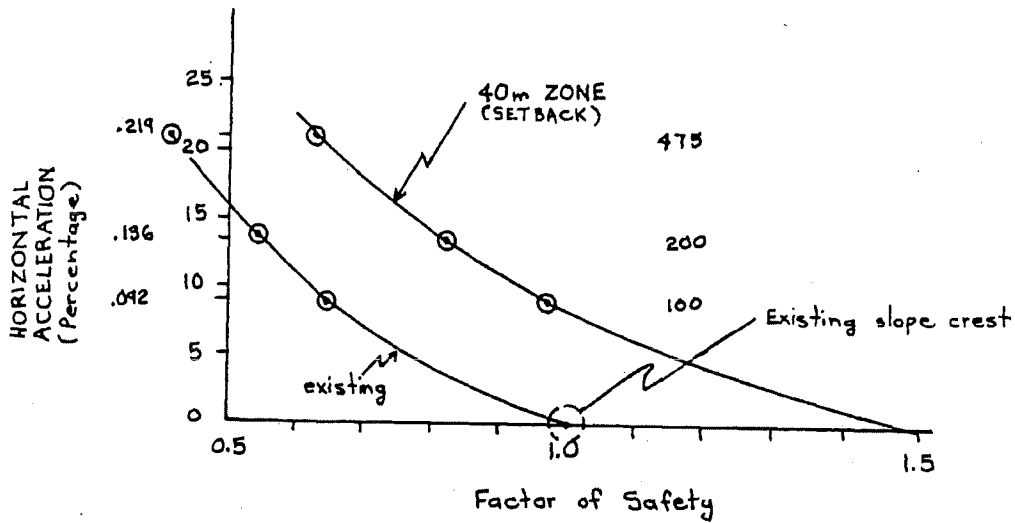
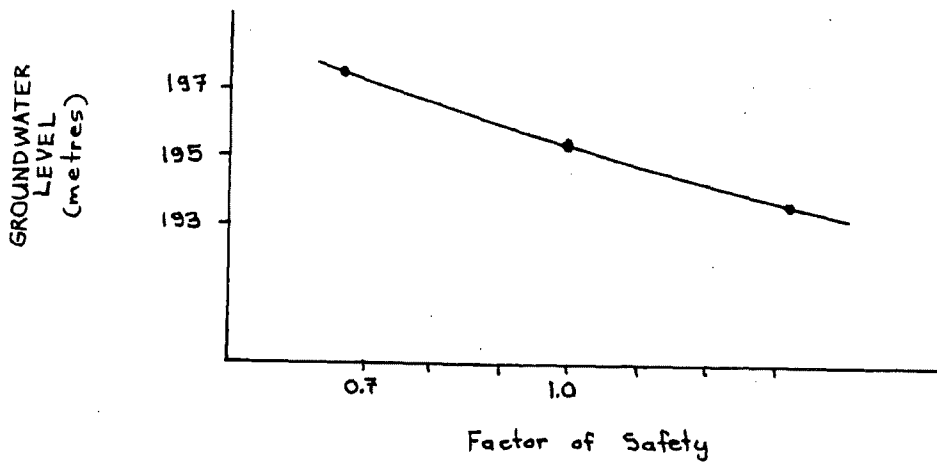
SEALAND
REGIME IV

Parametric Analysis
Regime IV - Sealand Park
North Slope - Nanaimo
