NORTH SHORE STABILITY STUDY
GEO TECHNICAL REVIEW OF THE EXISTING
SHORELINE SLOPE STABILITY

MARCH 1993

CITY OF NANAIMO

HBT AGRA LIMITED
Nanaimo, B.C.

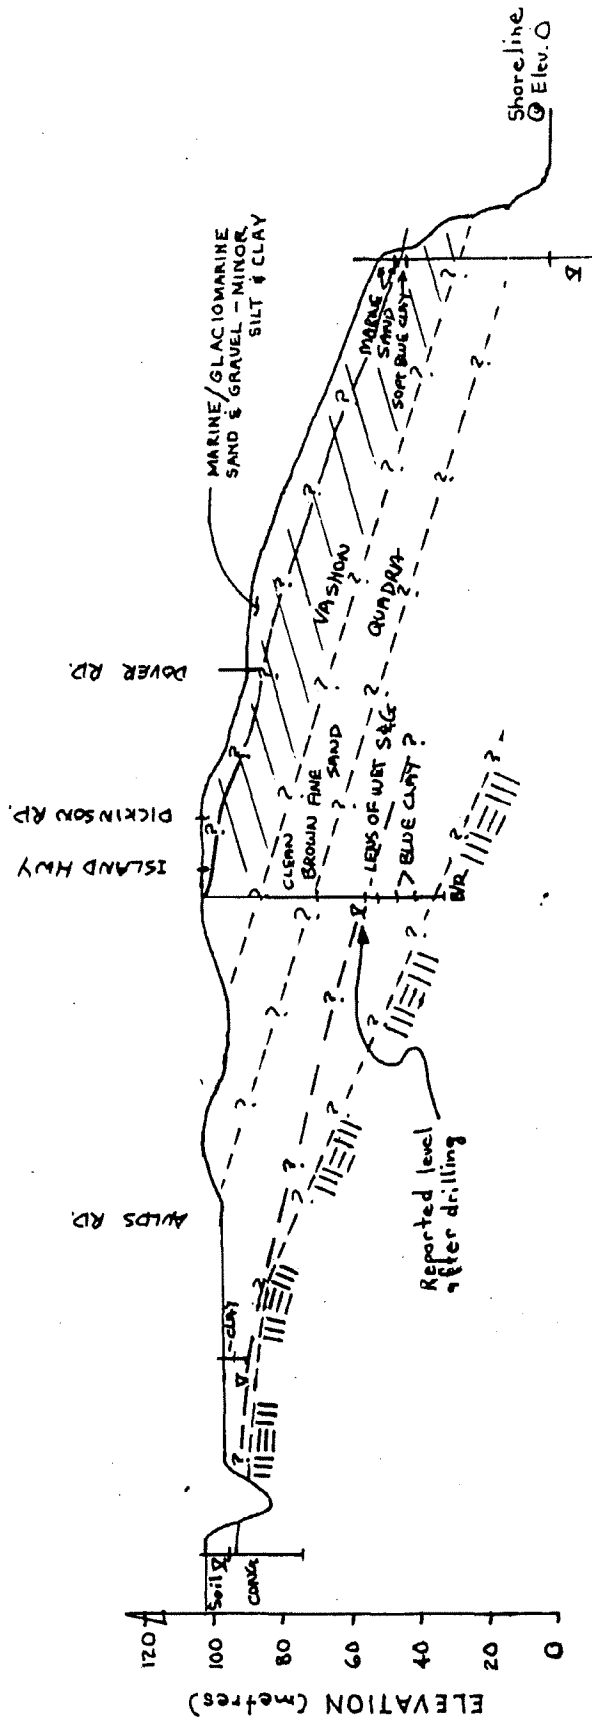
Figure 3.7

- Lantzville to Icarus Point:
In this area, flow is likely north through significantly thicker deposits of the Quadra "Sands", as compared to the following two regimes. Significant seepage observed along the shoreline within Regime I may be a result of the significant thickness and hydraulic conductivity (transmissivity) of the sand units (refer to Figure 3.7).

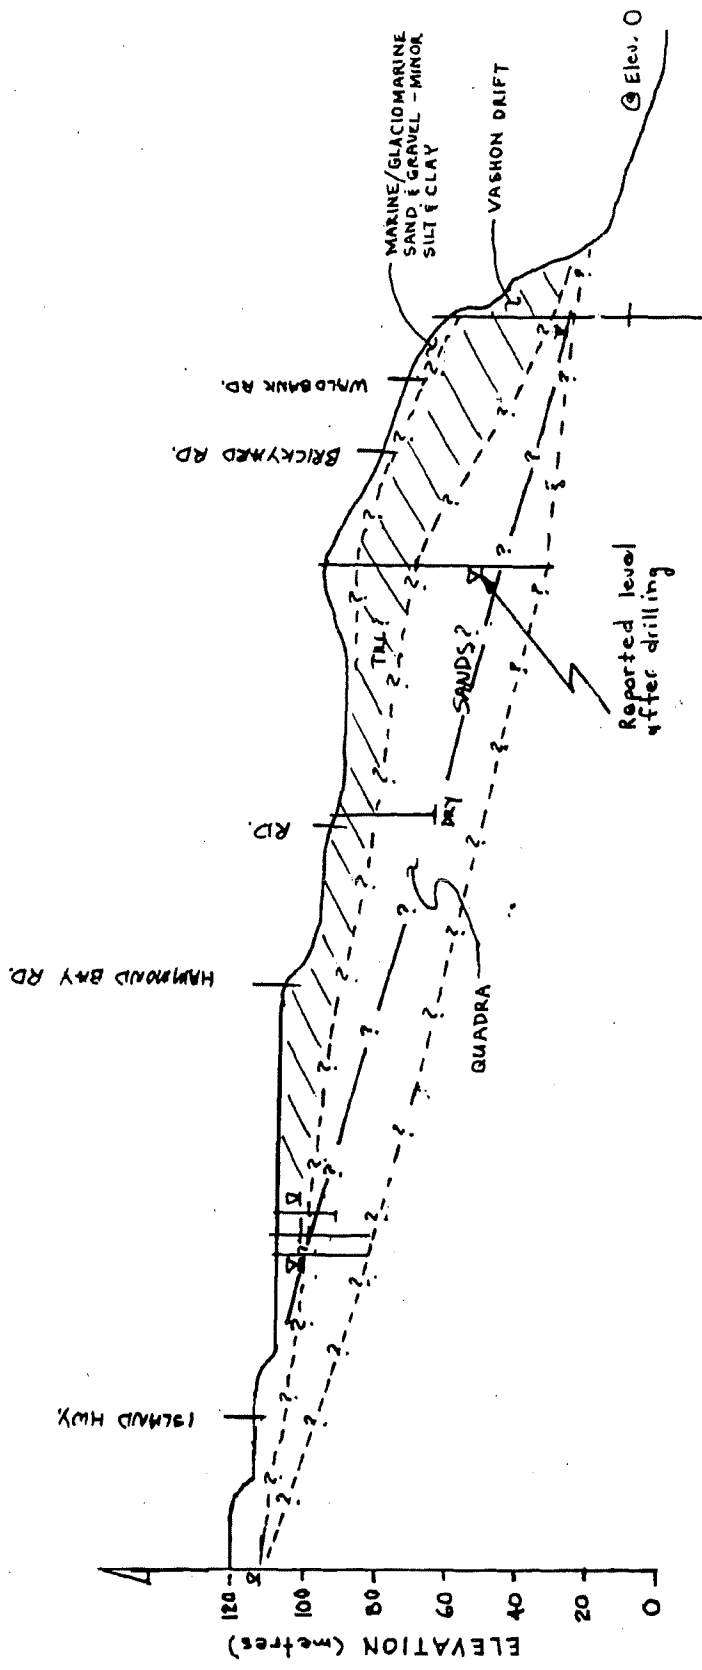
Figure 3.8

- Icarus Point to Norasea Road:
This area corresponds to the Molecey Creek drainage area. Groundwater flow is likely to the northeast through confined deposits of Quadra "Sands" which may lead to "funneling" of groundwater and higher piezometric pressures. Significant seepage was noted throughout the area between Icarus Point and Molecey Creek (Regime III). Although seepage was also observed between Molecey Creek and Norasea Road (Regime IV), the quantity of flow was less. Most seepage in both Regimes appeared to discharge from Unit 4 above the lower Quadra silt/clay (Unit 2) (refer to Figure 3.8).

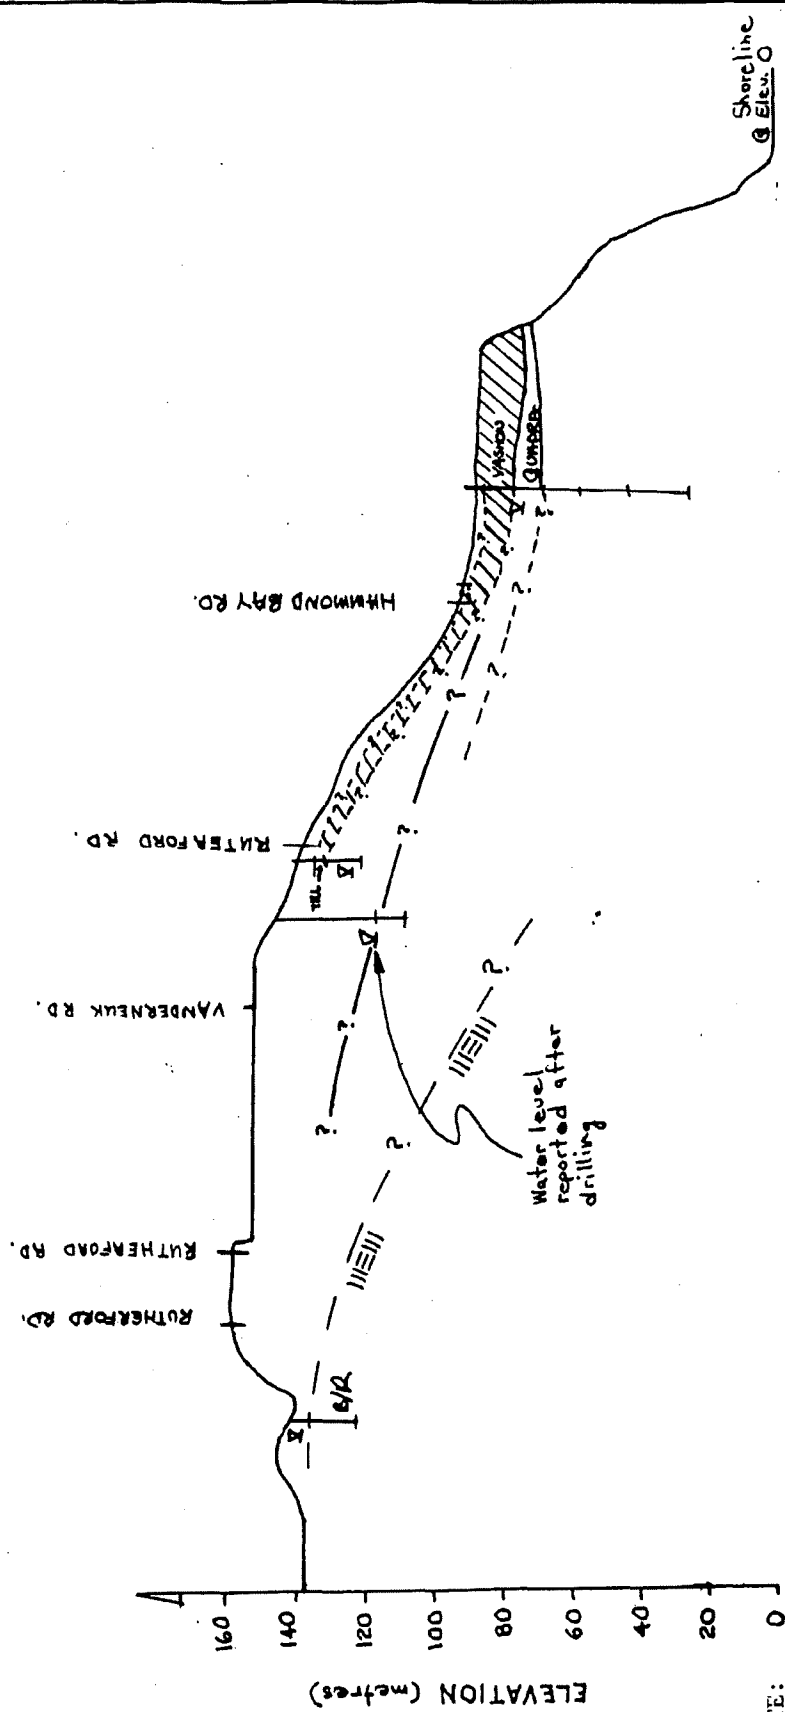
HBT AGRA Limited 3070 Barons Road, Nanaimo, British Columbia Canada, V9T 4B5	PROFILE 3 - 3' NORTH SLOPE - NANAIMO	
	Date <u>NOV/92</u> Drawn By <u>S.V.</u>	Figure 3.9

- Norasea Road to Fillinger Crescent:
Groundwater flow is to the north-northeast. Infiltration and recharge areas are interpreted to occur directly inland (south) and to the southeast of this area along Rutherford Ridge. Because the Quadra "Sands" pinch out to the east (general thinning of the glacial deposits occurs to the east as bedrock rises and outcrops along the shoreline near Entwistle Drive), groundwater flow is believed to be limited to coarse grained lenses of sand and gravel above the basal silt/clay Dashwood and Quadra silt/clay units (Units 1 and 2). Seepage points observed appear to correspond with past failures in this area (refer to Figure 3.9). High piezometric levels associated with bedrock have also been reported to the east of this area.

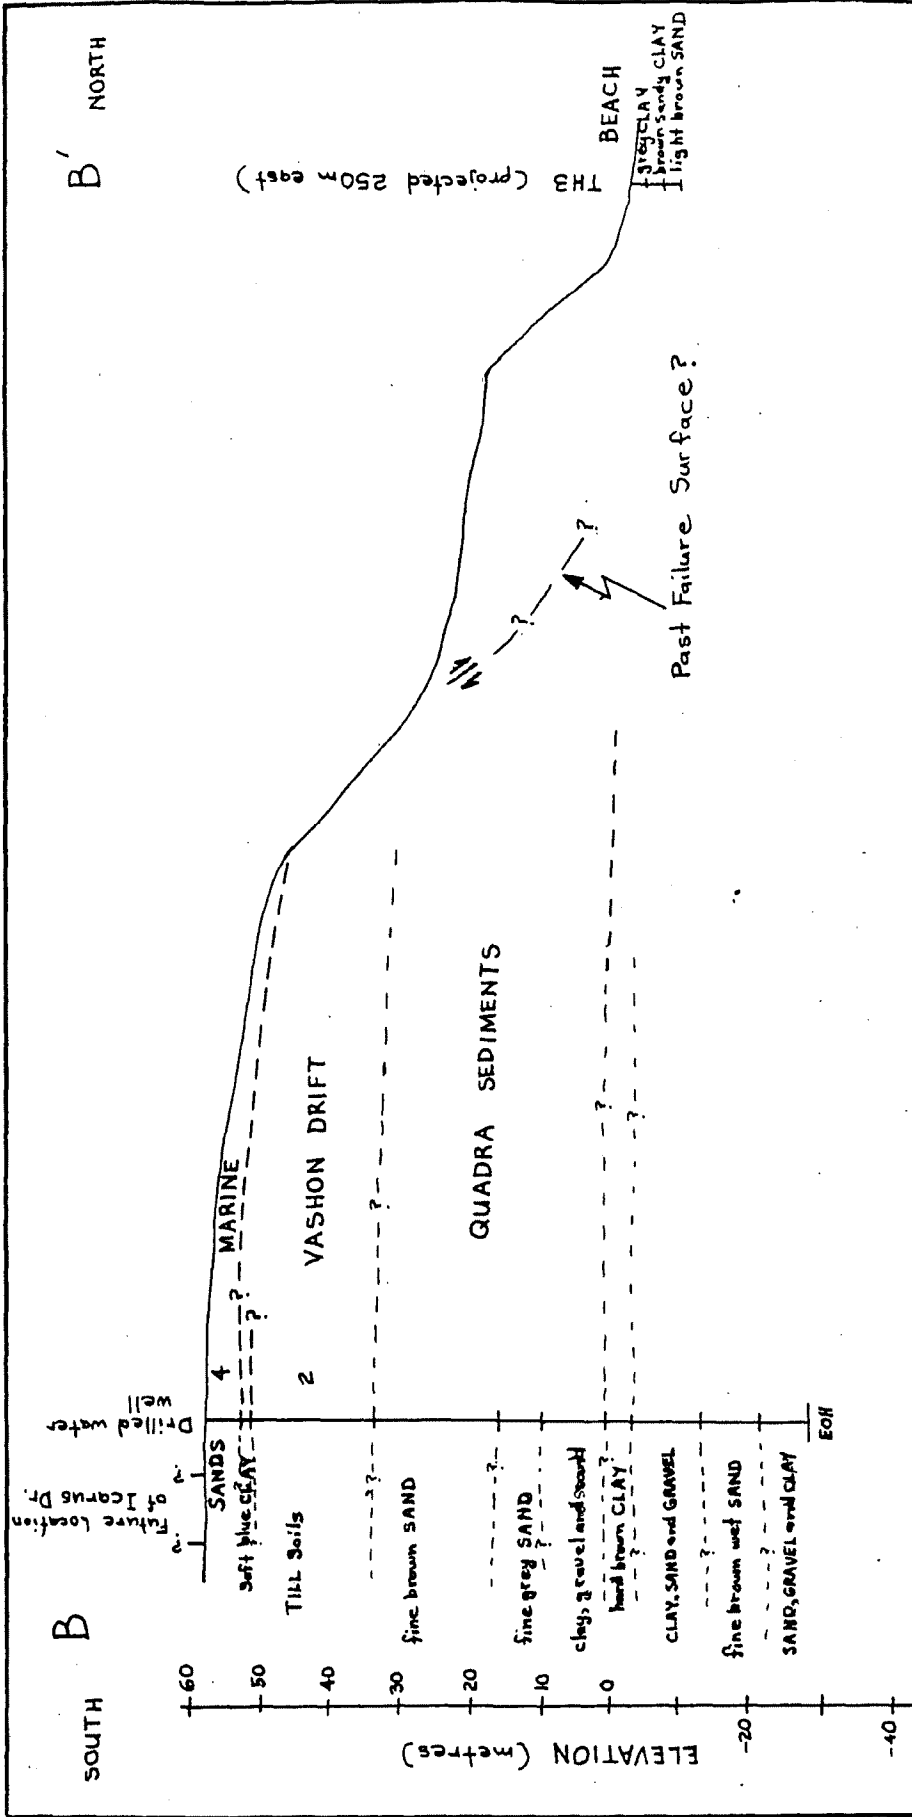
It was noted that the slope profile is dominated by a mid-slope terrace or level area located approximately 20 metres up from the base of the slope. In some places seepage was encountered on the surface of this level area. The break in slope coincides with the top of the grey clay (unit 2) which suggests a large block failure similar to Sealand Park (Regime IV) may have occurred in the recent geologic past. Less seepage was observed on the beach in this regime, with the exception of around Icarus Point.
