GUIDELINES FOR GEOTECHNICAL ASSESSMENTS ABOVE ABANDONED MINE WORKINGS

May 2024

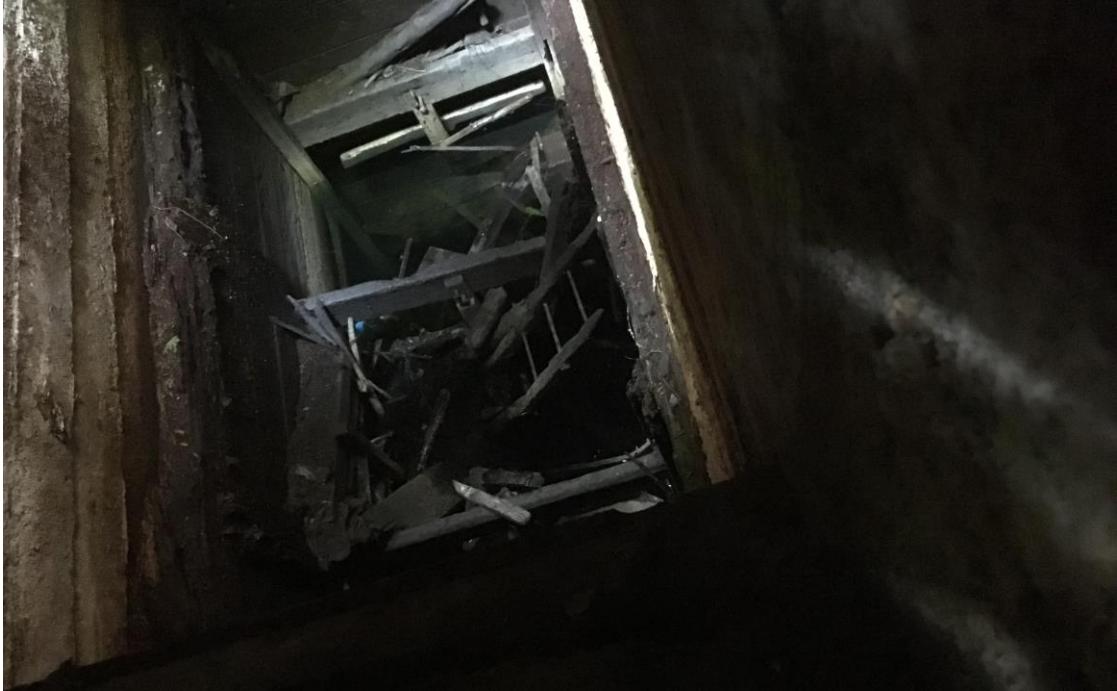
<p>Photo 1:</p> <p>Partially open mine shaft on Saysutshun (Newcastle) Island approximately 200 m deep</p>

- The potential for sudden ground collapse associated with all openings to mine workings and prospecting works including shafts, slopes, and adits. The preliminary assessment identified some 55 vertical shafts and some 35 inclined or level slopes and adits within the City limits. There may be significantly more unrecorded openings that were created for ventilation in shallow mines and related to the poorly recorded secondary mining extraction activities that followed the abandonment of the main workings. The attached Photo 1 shows an example of an open shaft on Protection Island while Photo 2 shows a partially collapsed unsupported slope leading to the shallow abandoned workings of the Fitzwilliam Mine; and

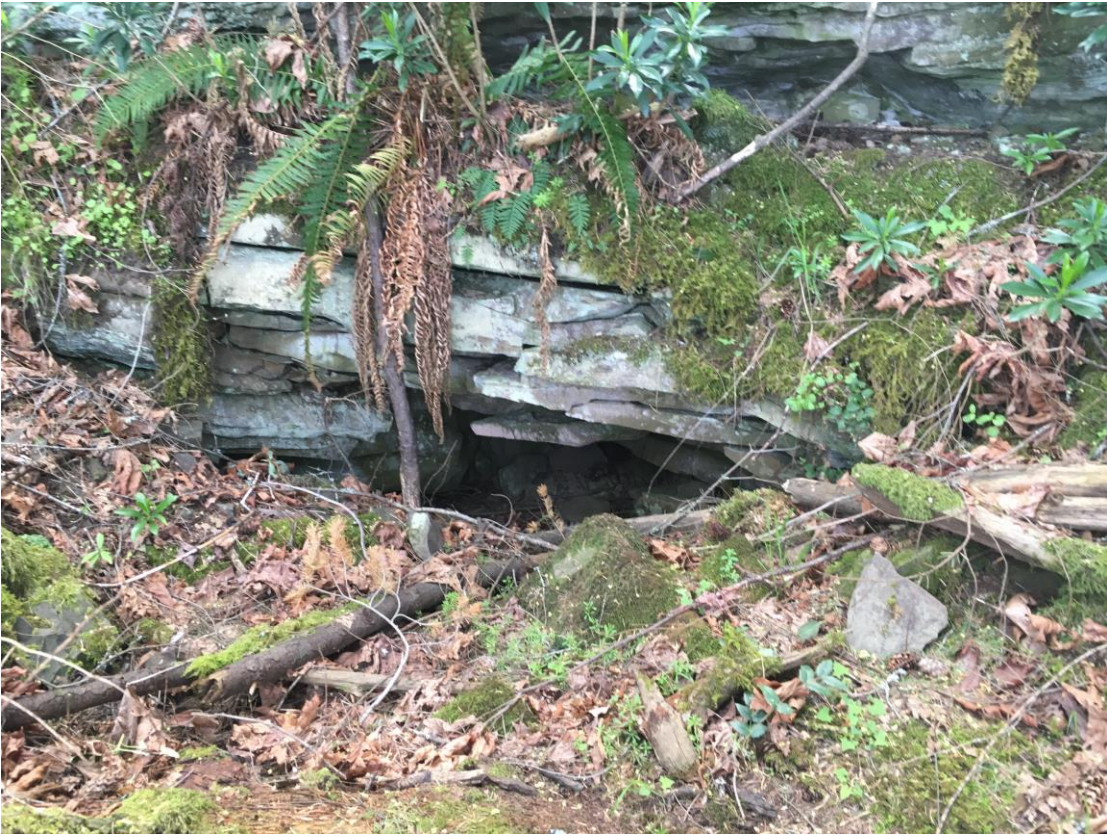
<p>Photo 2:</p> <p>Partially collapsed and backfilled slope entrance to the shallow abandoned workings of the Fitzwilliam Mine</p>

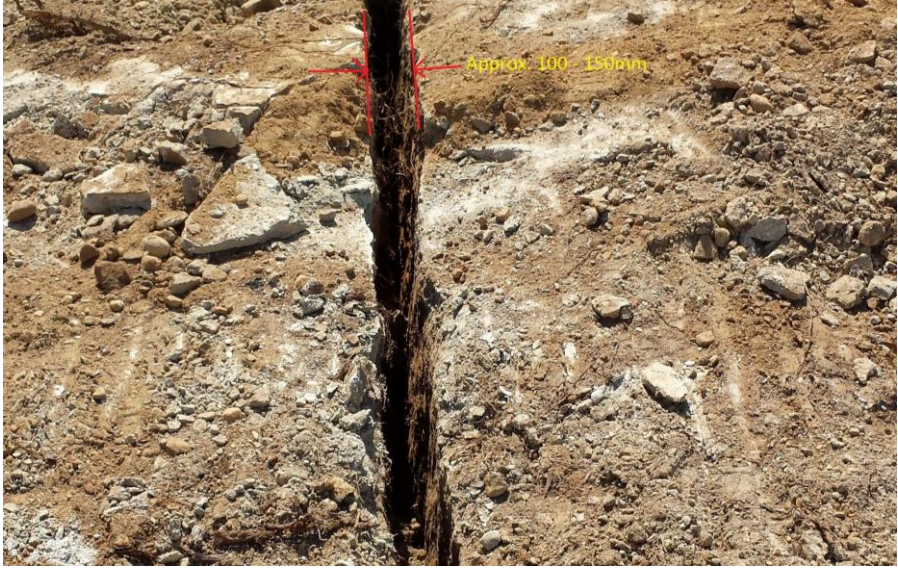
<p>Photo 5: Open fractures above shallow workings of the Wellington Mine in the Gilfillan Road area.</p>

- The potential for roof rock failure leading to a crown or sink hole at the ground surface in areas above abandoned room and pillar mine workings with an inferred roof cover of rock of less than 10 times the seam thickness. Specific areas of high risk related to this hazard include portions of the west side of the Douglas Mine; the shallow workings of the Fitzwilliam Mine at the north end of Saysutshun (Newcastle) Island; and the north-westerly portion of the Wellington Mines, where there is a complex history of extraction from two shallow coal seams along with a poorly documented record of secondary pillar robbing that extended into the 1960's. Photo 3 shows shallow partially collapsed open workings under Victoria Road while Photo 4 shows a portion of crown hole that was encountered at the western edge of the Douglas Mine during a shallow utility replacement program. Photo 5 indicates the nature of open fracturing above the shallow abandoned Wellington Mines in the Gilfillan Road area.

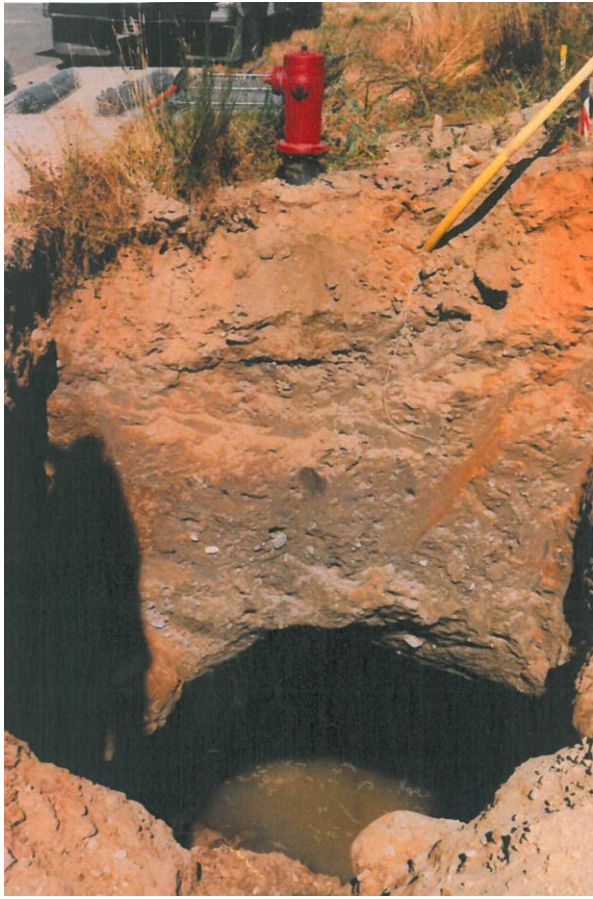
<p>Photo 6: Secondary migration of soil resulting in open void and sinkhole in the Horth Road area near Divers Lake. Note presence of watermain and gas in vicinity of sinkhole.</p>
